Rich Radenbaugh p. 310-408-8147 e. bwroofingandsolar@gmail.com

Mishkon Sanctuary

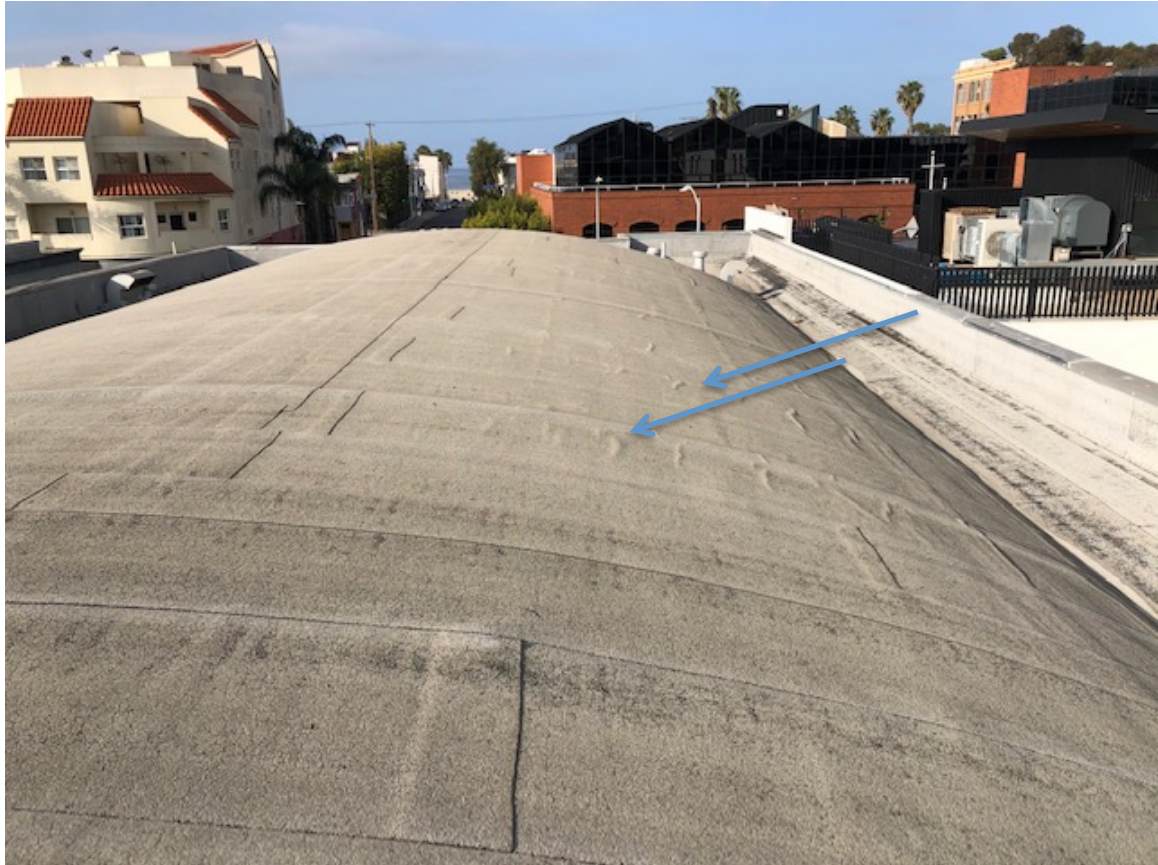
Signs of water intrusion can be seen from the ripples in the roof cap-sheet.

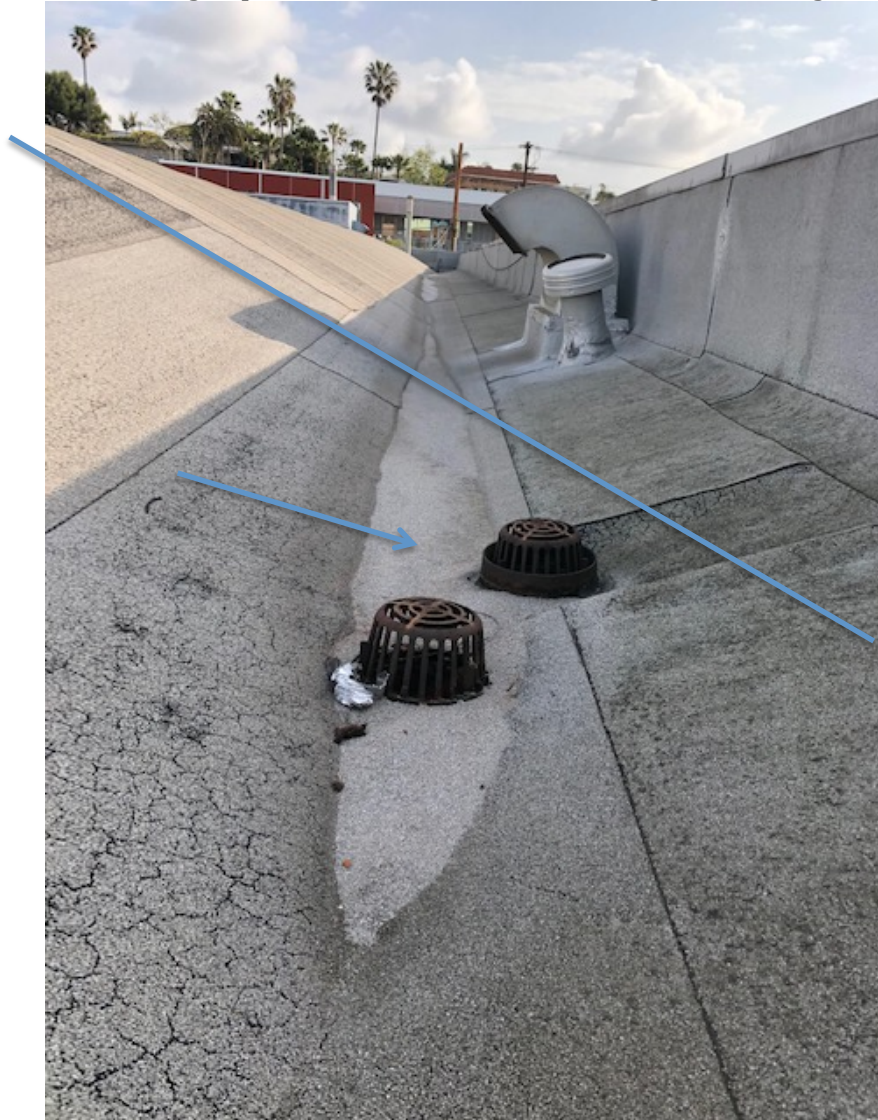
Roofing granules are coming off the roof at a very quick rate (Blue arrow). The cracking in the capsheet is allowing water to saturate the capsheet and get into the roof system.

The blue line represents the interior sloping of the ceiling to the wall. Anything that gets under the roof system can be caught by the drywall interior and flow toward the wall.

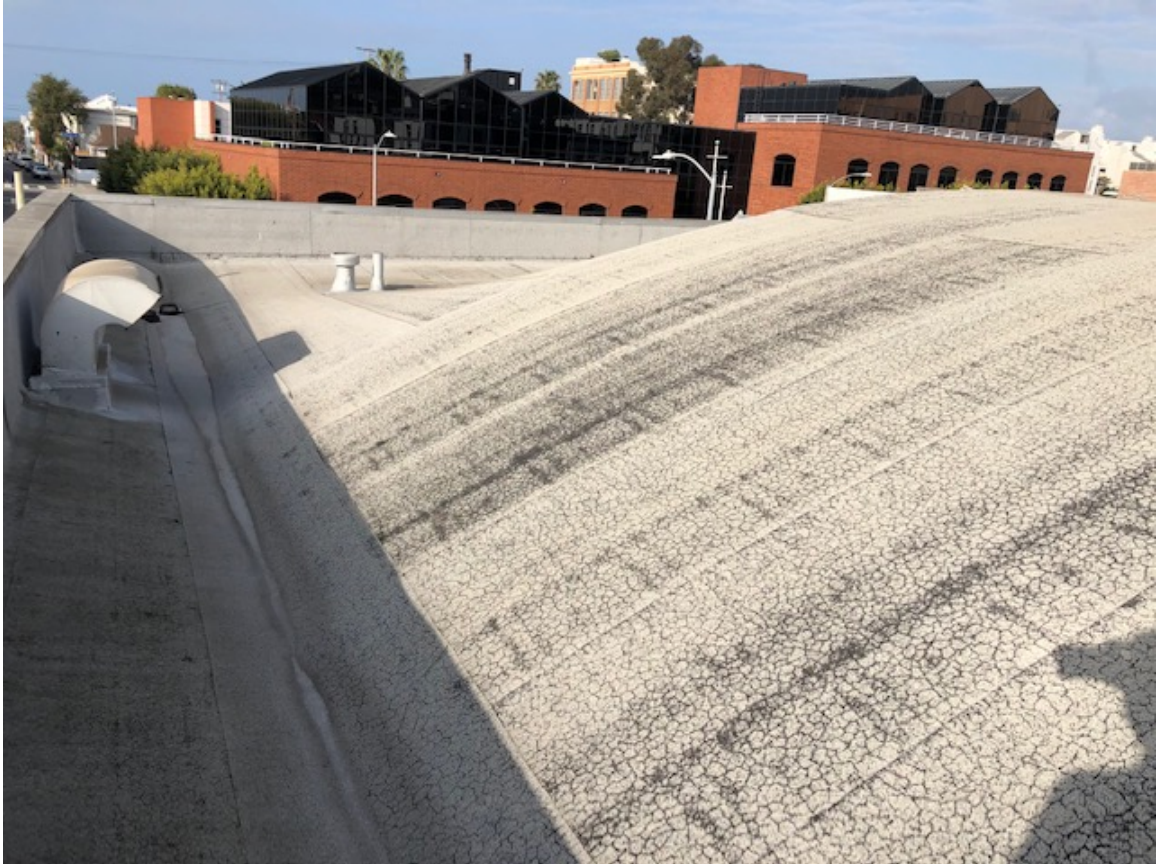
Here is another picture of the cracking capsheet..

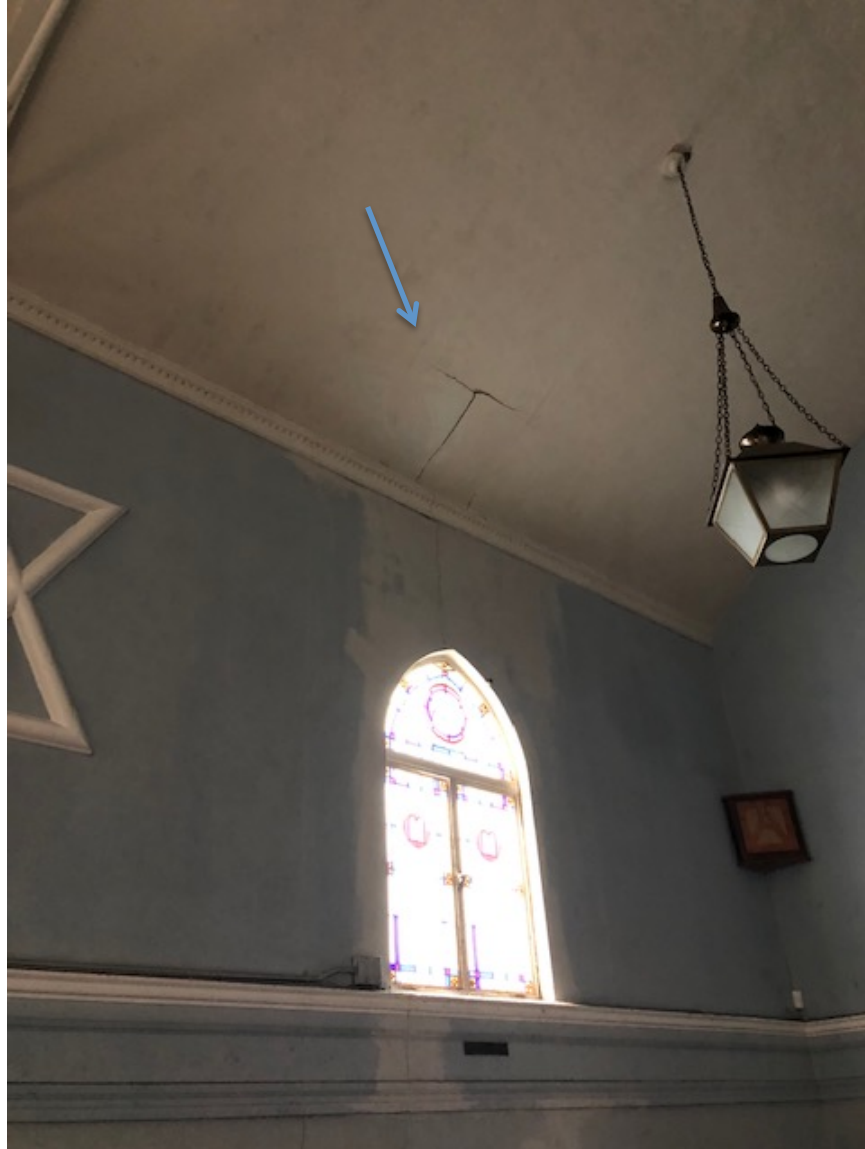
The crack in the ceiling is confirming the water is getting into the roof system above the troughs or where the drains are located. Also the wall discoloration and most likely window damage would be caused by this as well.

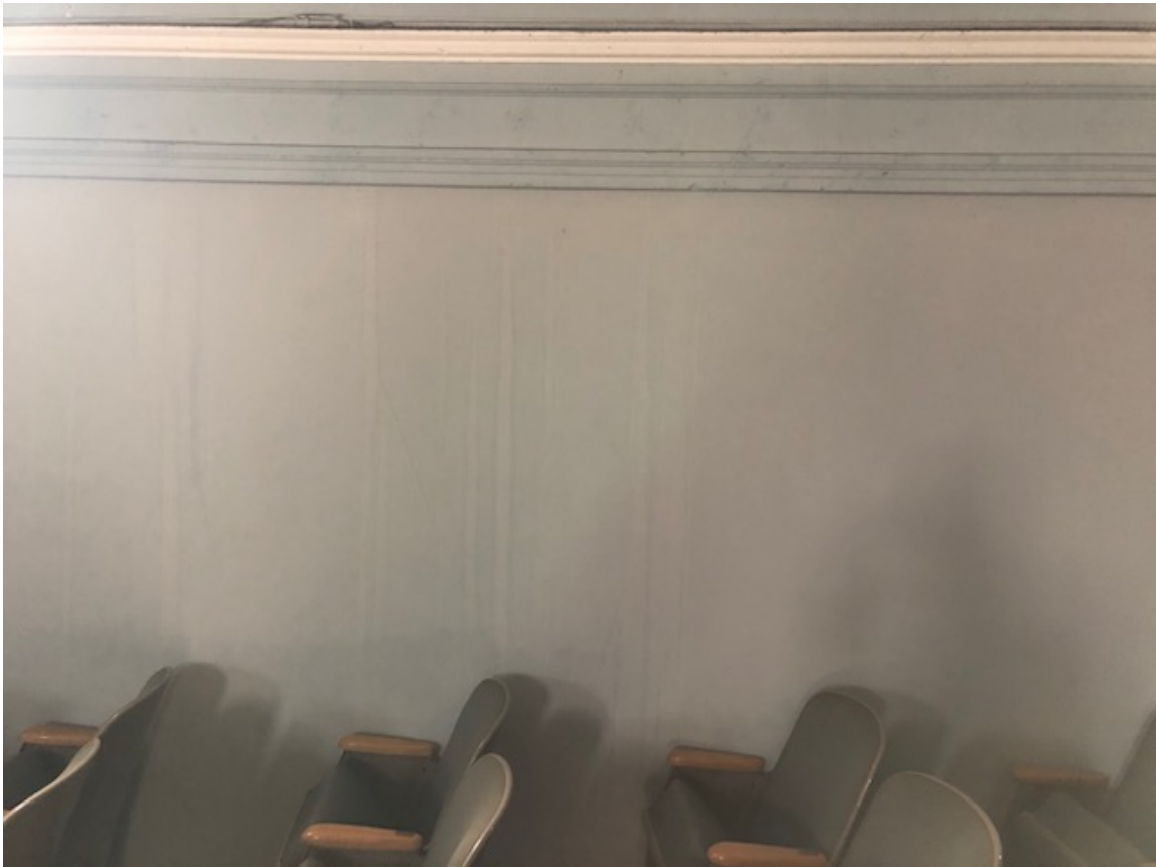
Here are the images of watermarks (vertical lines) that are above grade and not located near a window.

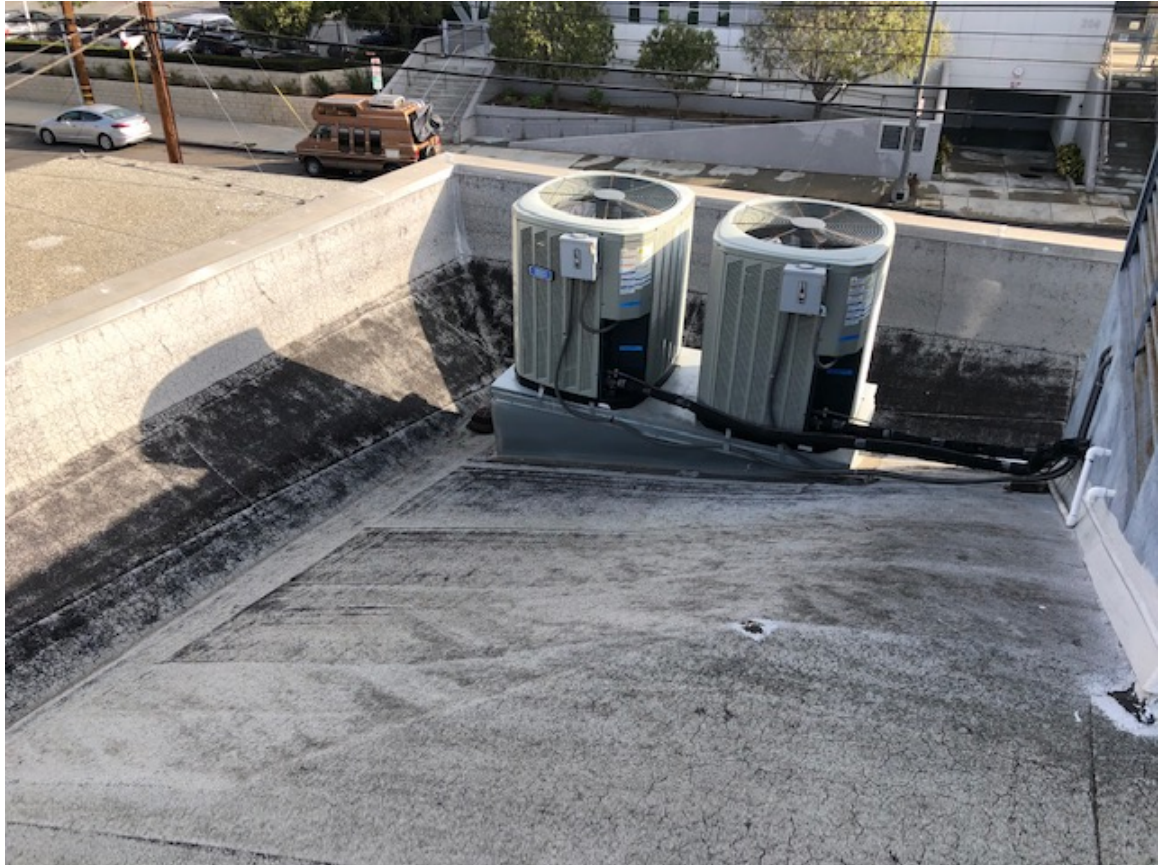
AC units are sitting on a metal platform that is not roofed in properly. This along with the rust that has begun is allowing water into the building.

This problem was fixed in May 2021. —David Stein

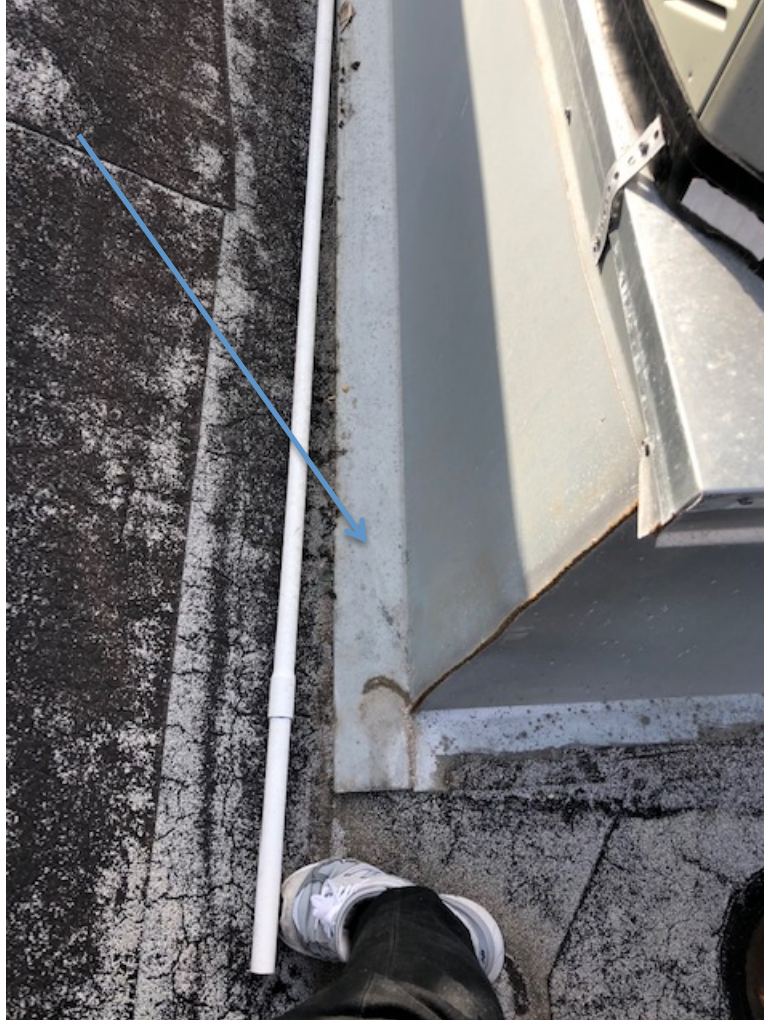
This is the low side of the AC platform near the drains. This flange (blue arrow) should be under the roof surface all the way around. As it is seen in the picture, water is able to get right under the AC box.

This problem was fixed in May 2021. —David Stein

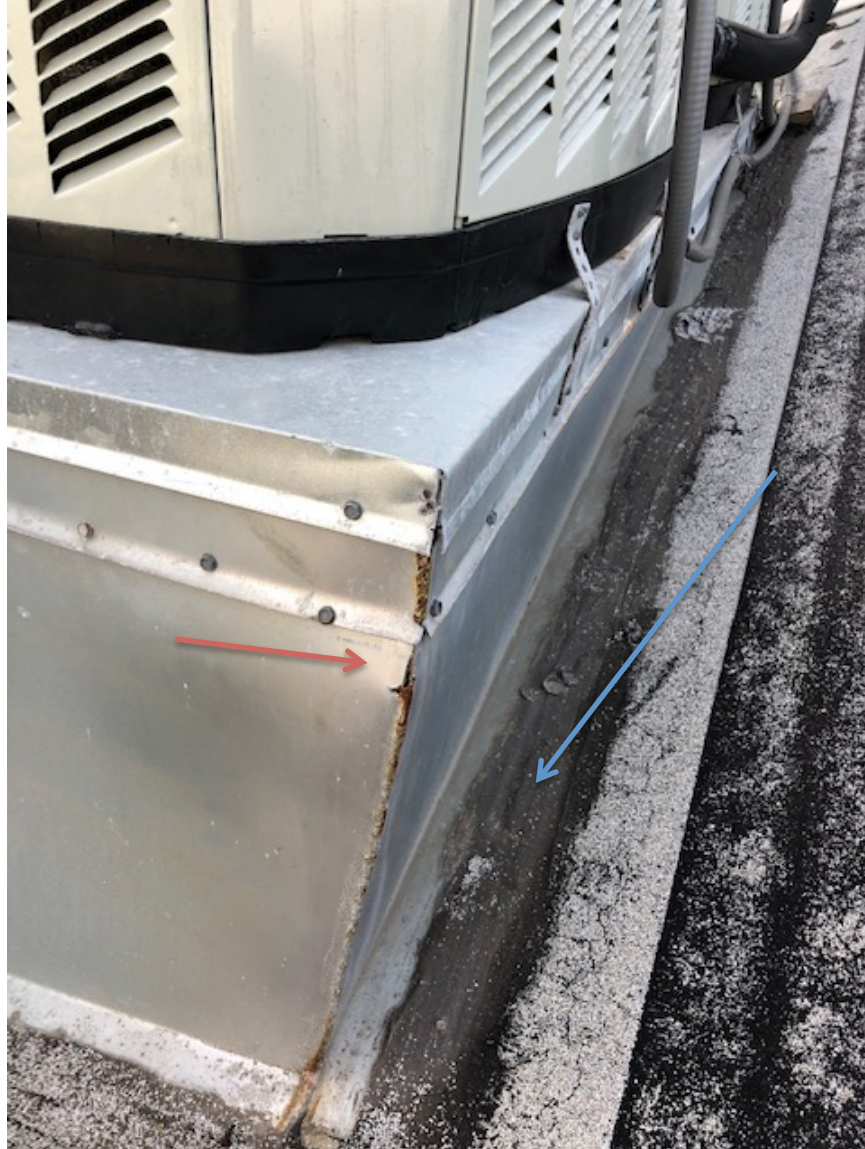
Instead of properly roofing the AC box into the roof system, the installers just tried to seal it. (blue arrow)

The galvanized metal is now beginning to rust and along side a very bad roof surface, water is getting into the building. (red arrow)

This problem was fixed in May 2021. —David Stein

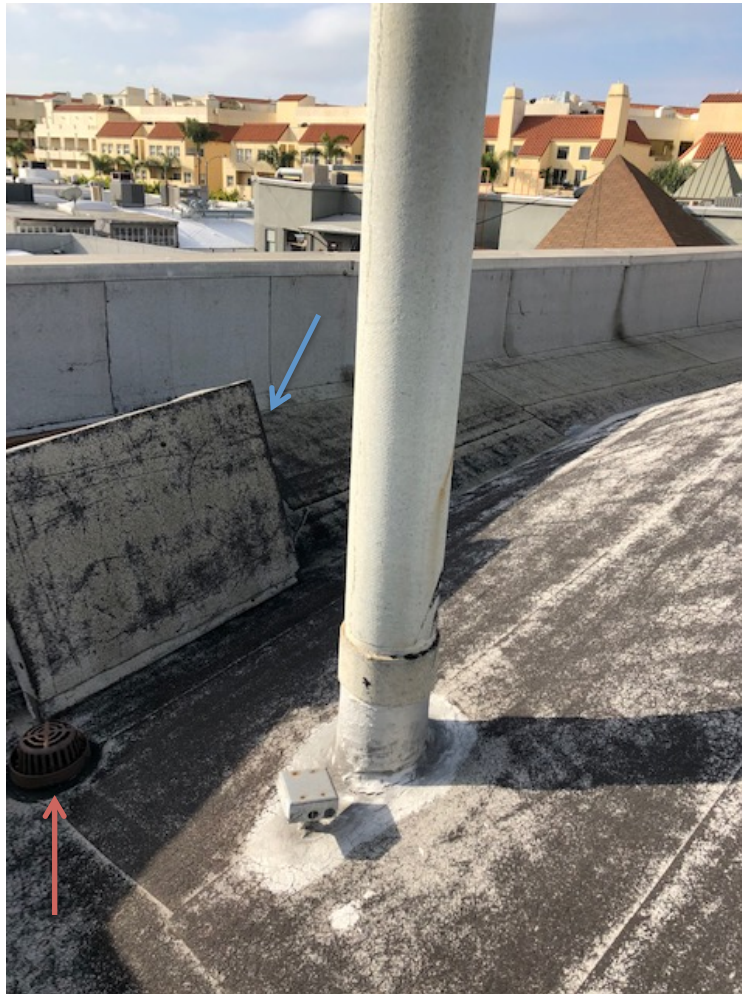
Roof hatch area...

This picture is showing the lack of roofing granules on the cap-sheet. It is shown as the black area in this picture. Take note of the drains location. (red arrow)

Blue arrow is showing the main st. side of the roof hatch.

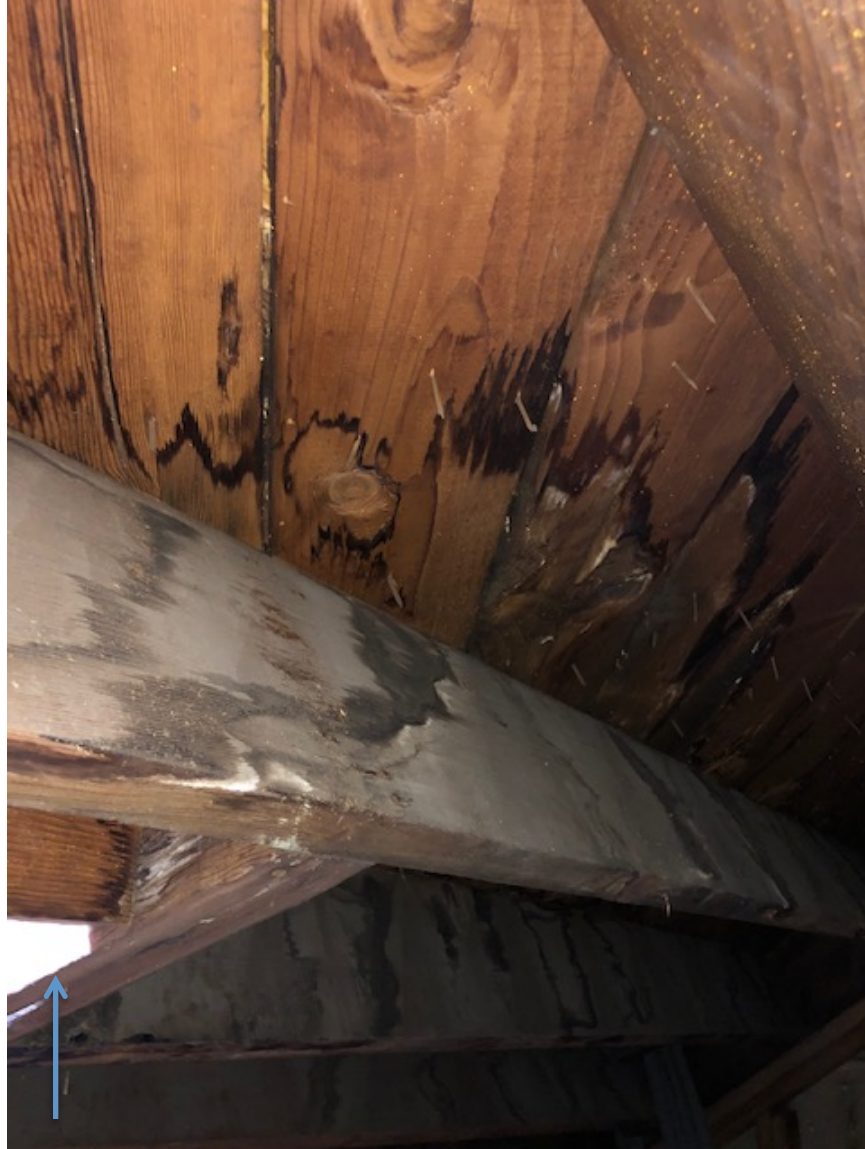
This is water damage from the roof showing in the wood substrate. The main st. side of the roof hatch is the bright light. (blue arrow)

The drain is 3 feet to the left and below this water damage.

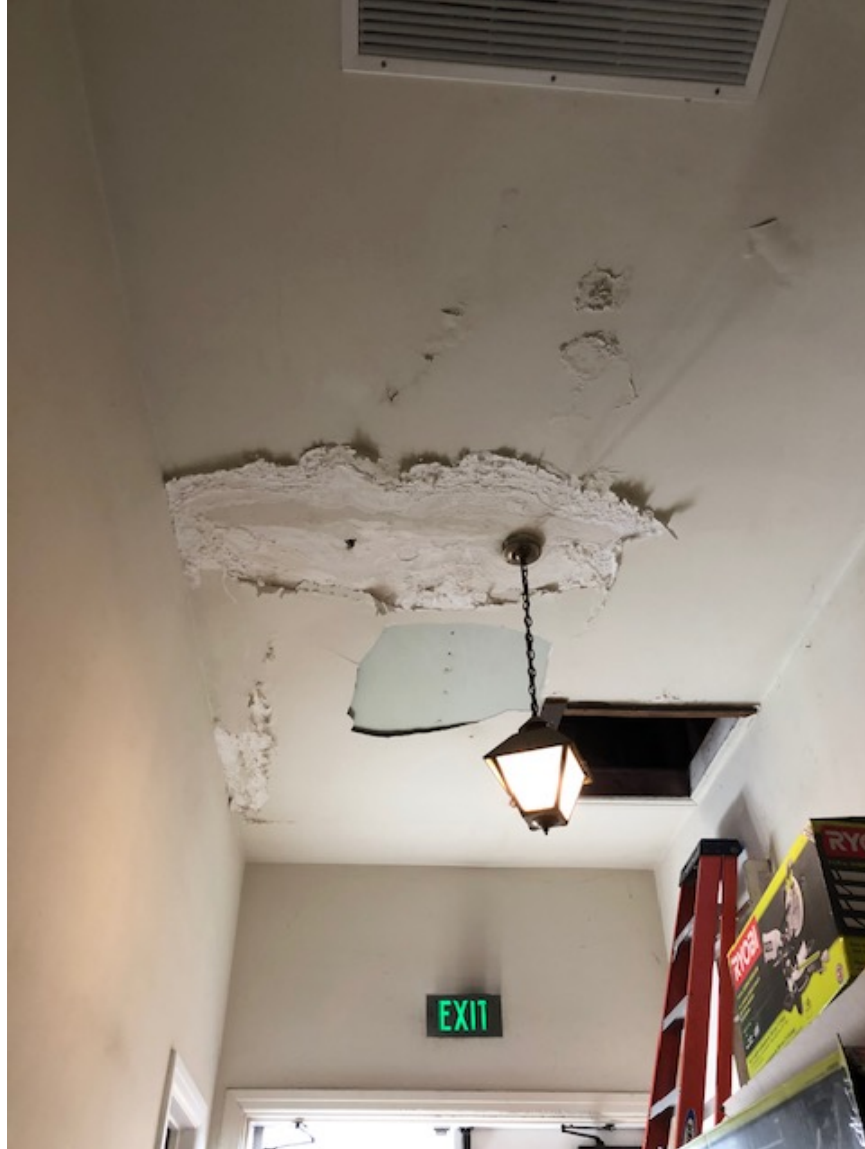
This is in the corridor between the sanctuary and the play yard. —David Stein

This damage is being caused by the water seeping through the roof surface and dripping down from the roof joists.

I am happy to look into the roof attic more in depth to confirm my findings as well.

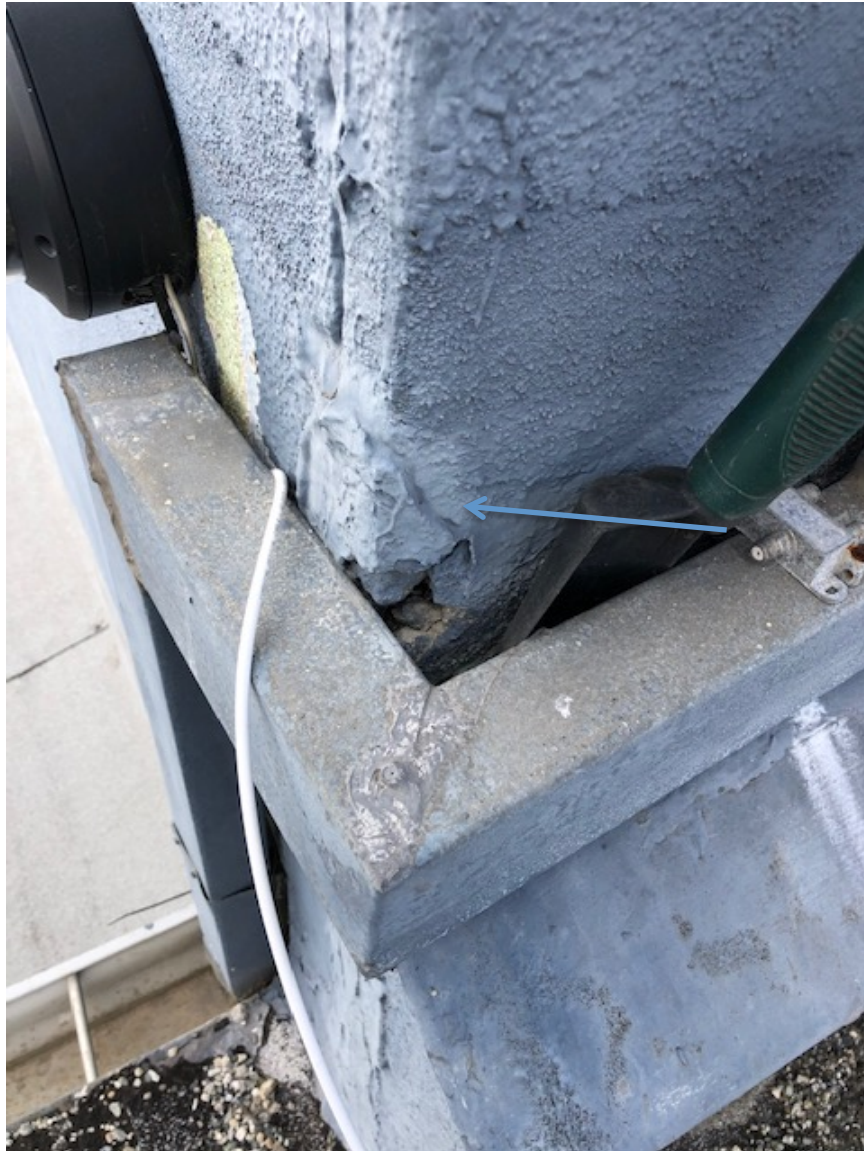
Stucco work needed on the office/classroom side building.

This problem was fixed in Nov. 2021. —David Stein

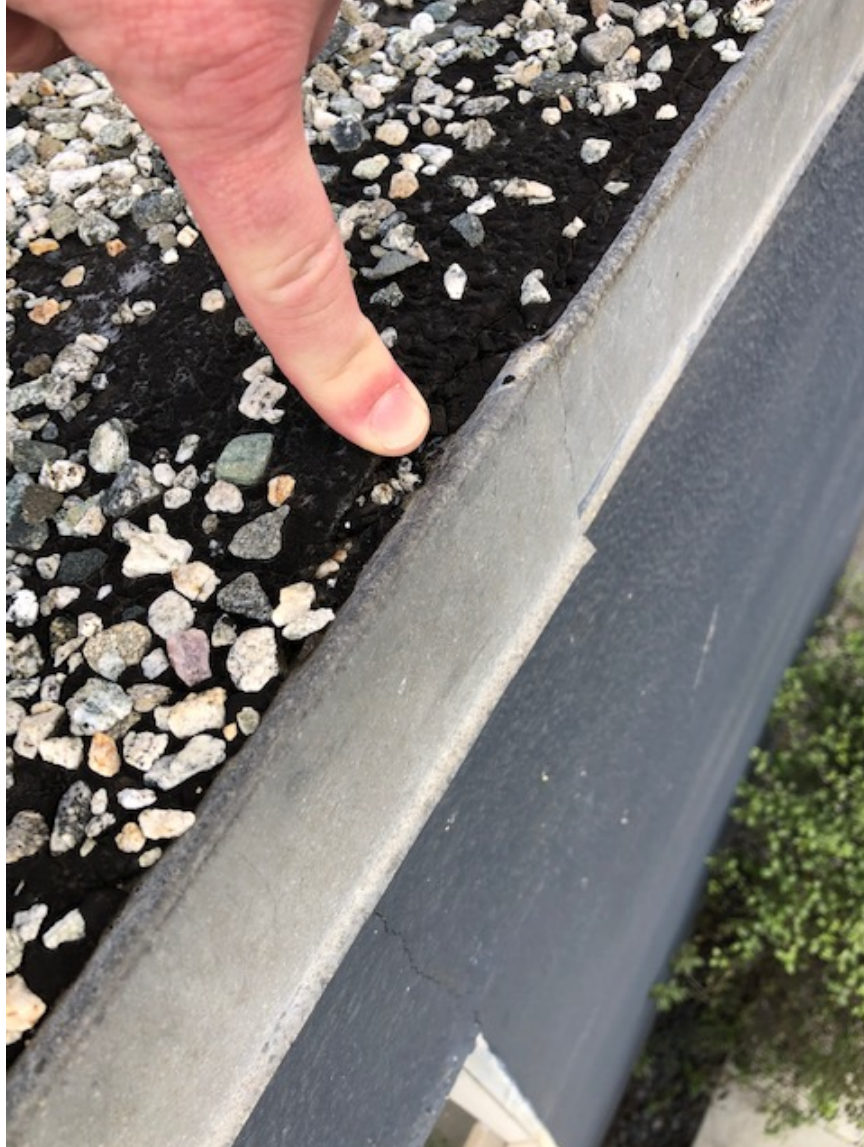
Edges of the building are starting to separate from the edge metal. This can be resealed or the perimeter can be cut back and reroofed for a more permanent repair.

This problem was fixed in May 2021. —David Stein

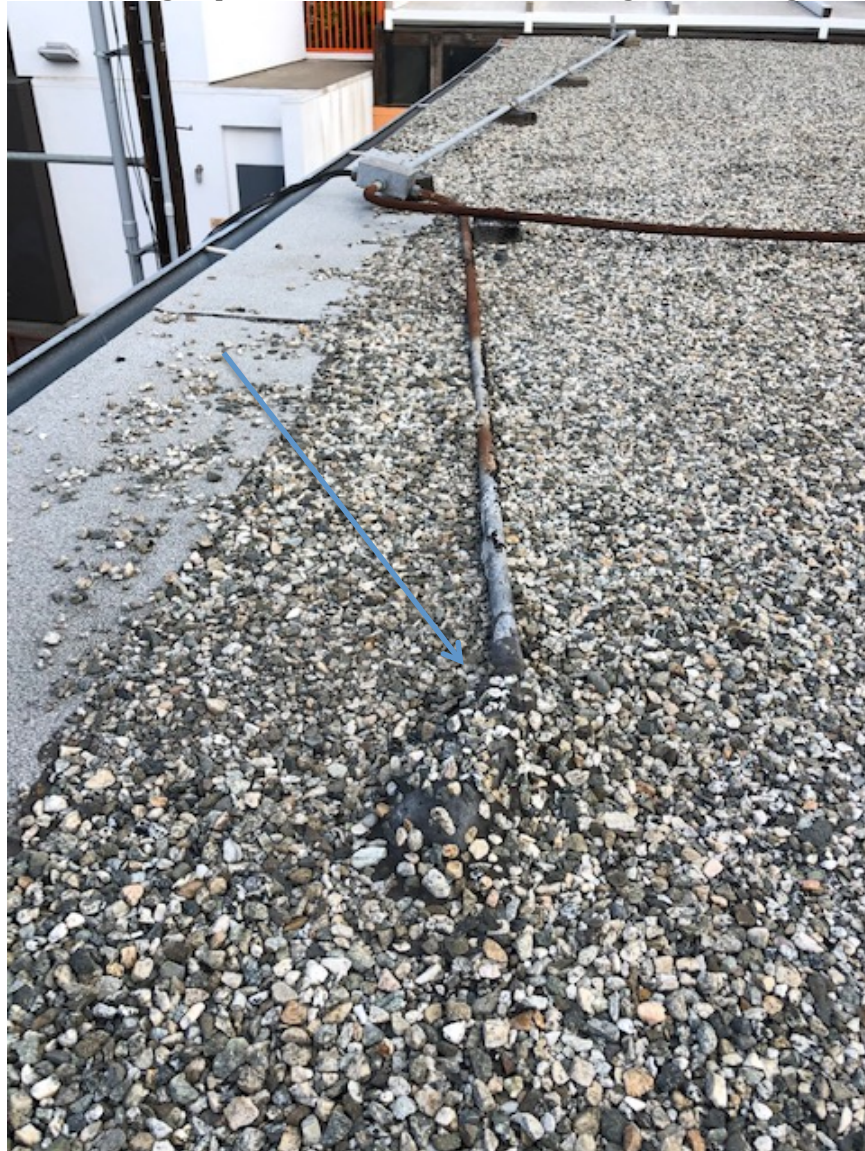
Electrical conduit is running through the roof surface but should be piped out through a T-Top flashing.

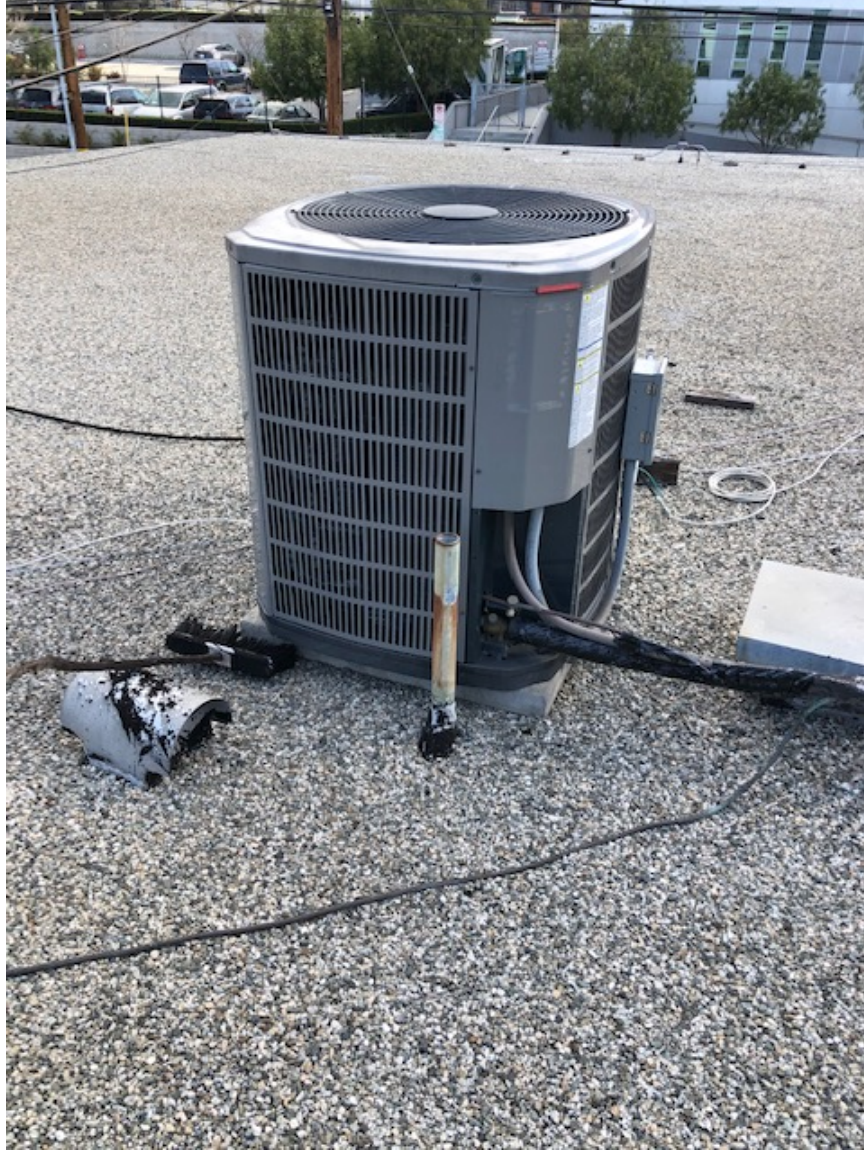
AC unit should be installed on a proper platform that is waterproofed correctly. Other helpful alterations could be installing a roof drain in the low areas of the roof that are showing ponding water. The drains can be installed and a pipe can be run through the soffit in the ceiling.
